Manhole Inspection Summary

Manhole # S69Q__008MH

Insp Date: **4/22/08 9:00 AM**

Location Address: **1504 Dundalk Ave.**

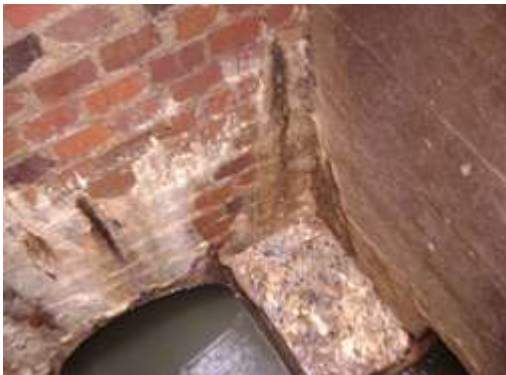
Defect 3

Infiltration: ☐ None ☒ **Joint** ☐ Cracks ☒ **Mortar** ☐ Roots ☐ Wall

infiltration in barrel wall

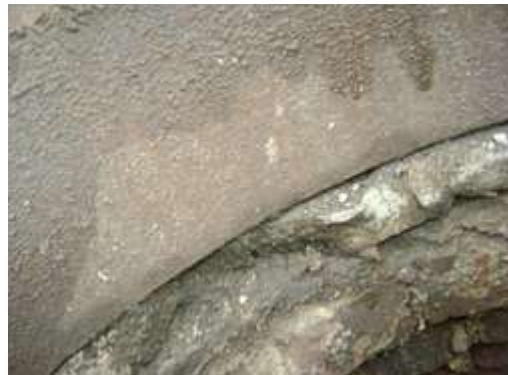
Defect 1

Condition: ☐ Sound ☐ Cracked ☐ Root Intrusion ☐ Loose Brick ☒ **Deteriorated**

Infiltration: ☐ None ☒ **Joint** ☐ Cracks ☒ **Mortar** ☐ Roots ☐ Wall

cracked mortar at frame seal

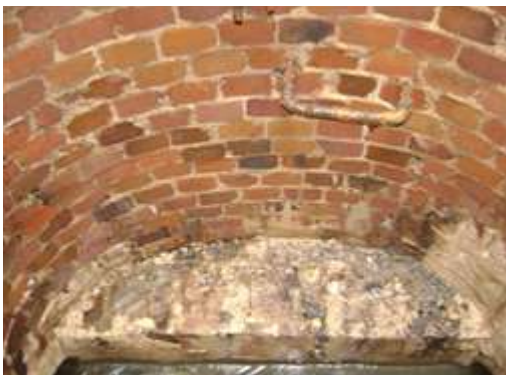
Defect 4

Condition: ☐ Sound ☐ Cracked ☐ Root Intrusion ☐ Deteriorated ☐ Leaks ☒ **Debris**

debris on bench

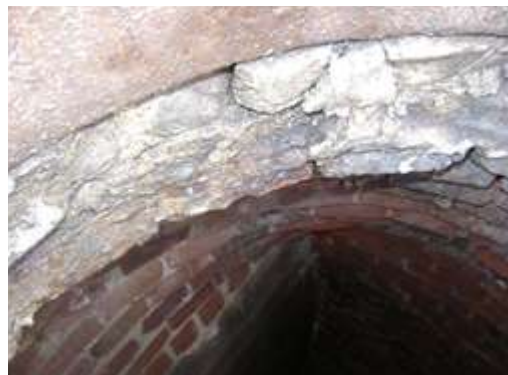
Defect 2

broken mortar at frame seal

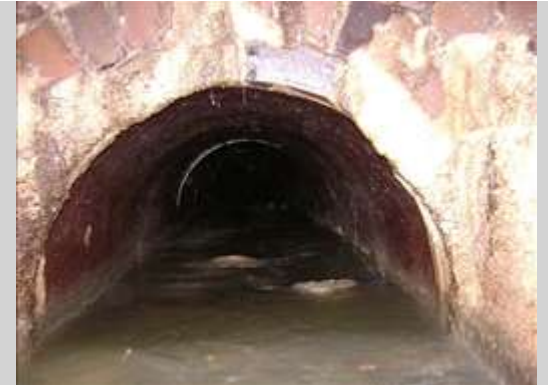
12 O'Clock Outflow

Pipe Height: **25.2** (in.) Rod and Bar (Angled)
Pipe Material: **Clay** ☐ Pipe Lined
Invert Depth: **12.75** (ft.) Flow Characteristics: **Slow**
Deposits: ☐ None ☒ **Mud** ☐ Sludge ☒ **Debris** ☐ Grease
Silt Depth: **2** (in.) Deposits Extent: **Light**
Infiltration: **None** Pipe Seal Cond: **Sound**
